2010 Dodge Ram 9.25 ZF AXLE TECH

- At some point in 2010 Ram, Fiat, Dodge, Chrysler changed the rearend from the standard Chrysler 9.25 to the ZF style 9.25. This article is written to help identify the differences so customers can order the correct parts and identify issues with the production axles.

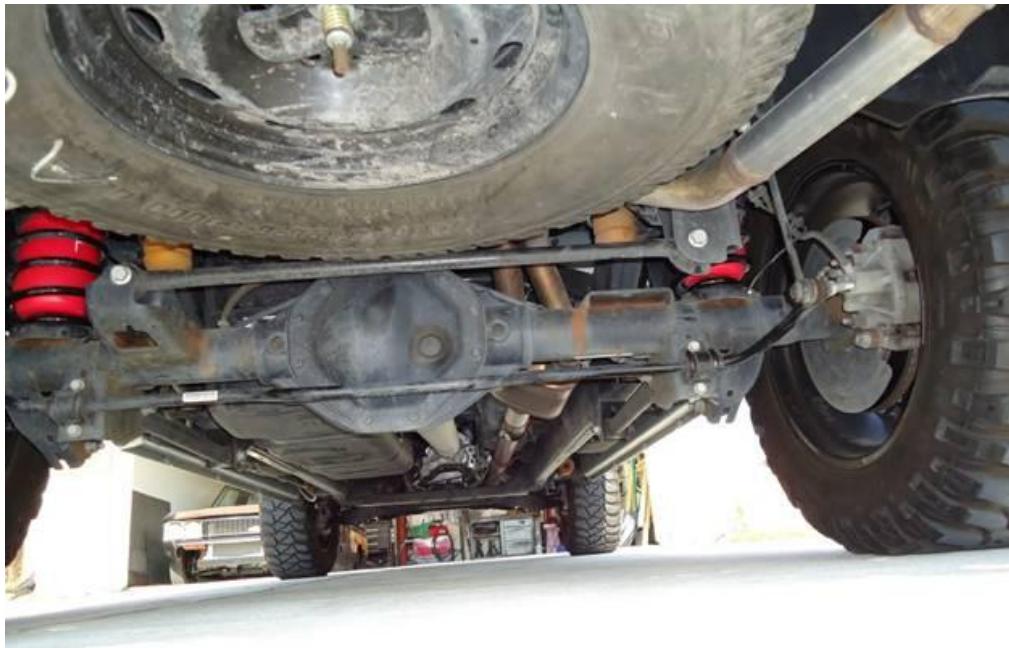
STANDARD 9.25 REAR END 4TH GEN 2009 SOME 2010

- *NO BUMP OUTS ON DIFF COVER AT AXLE CENTERLINE HAS RUBBER PLUG

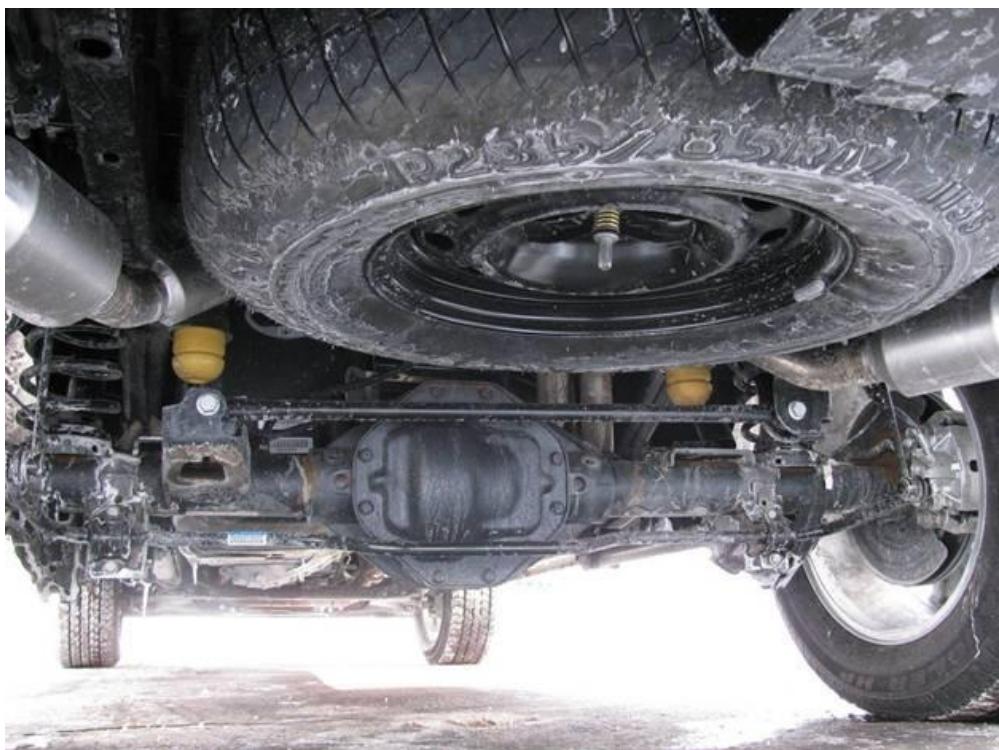
2010 AND NEWER ZF STYLE

- BUMP OUTS ON COVER NO FILL HOLE ORIGINAL COVER

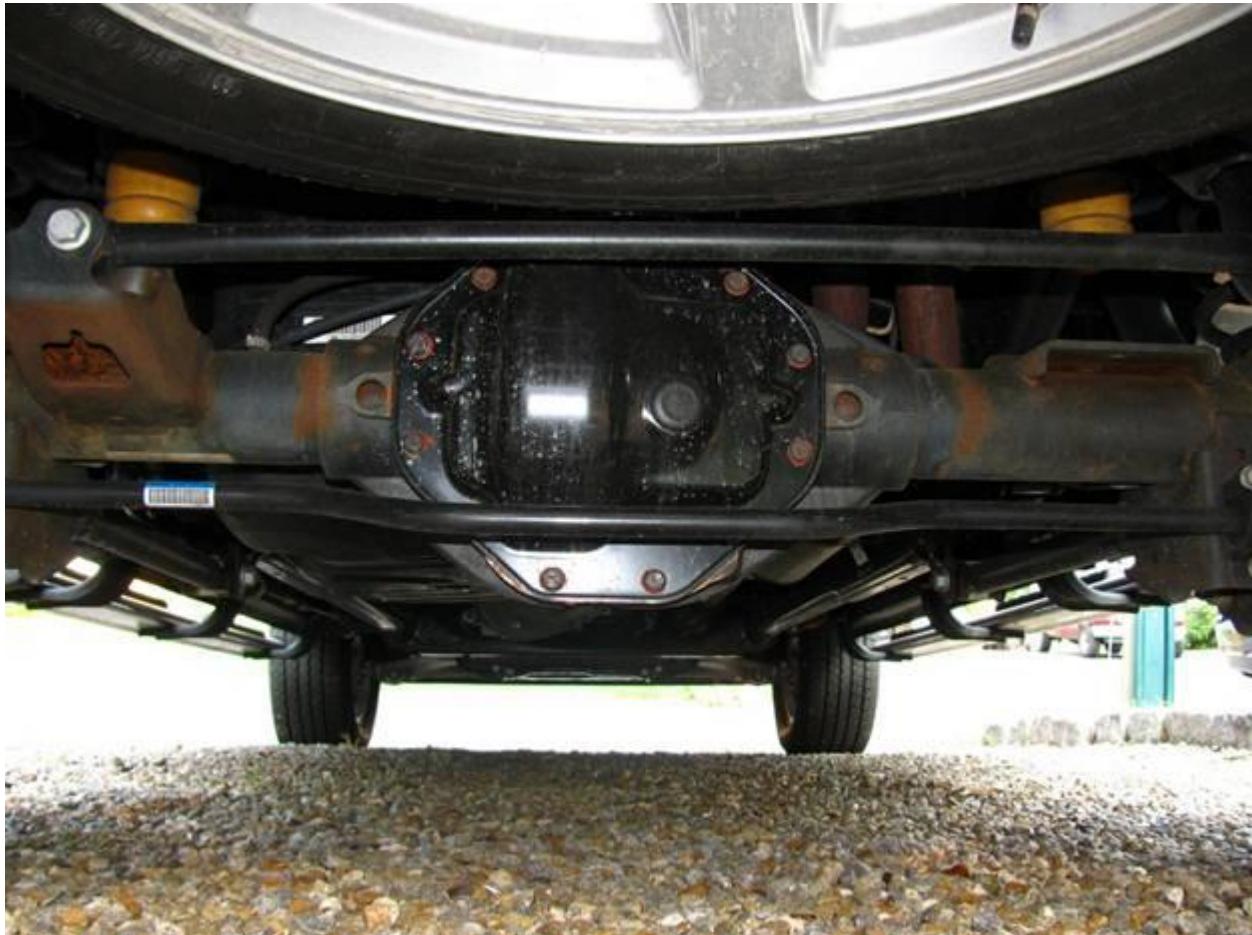
2010 TO CURRENT ZF REAREND

- NEW STYLE COVER WITH FILL PLUG FACTORY INSTALLED 2012+ ALSO INSTALED UNDER RECALL
