Toyota Rear Third Member Flange Identification

In order to verify what type of pinion seal on the following listed vehicles please refer to the picture below.

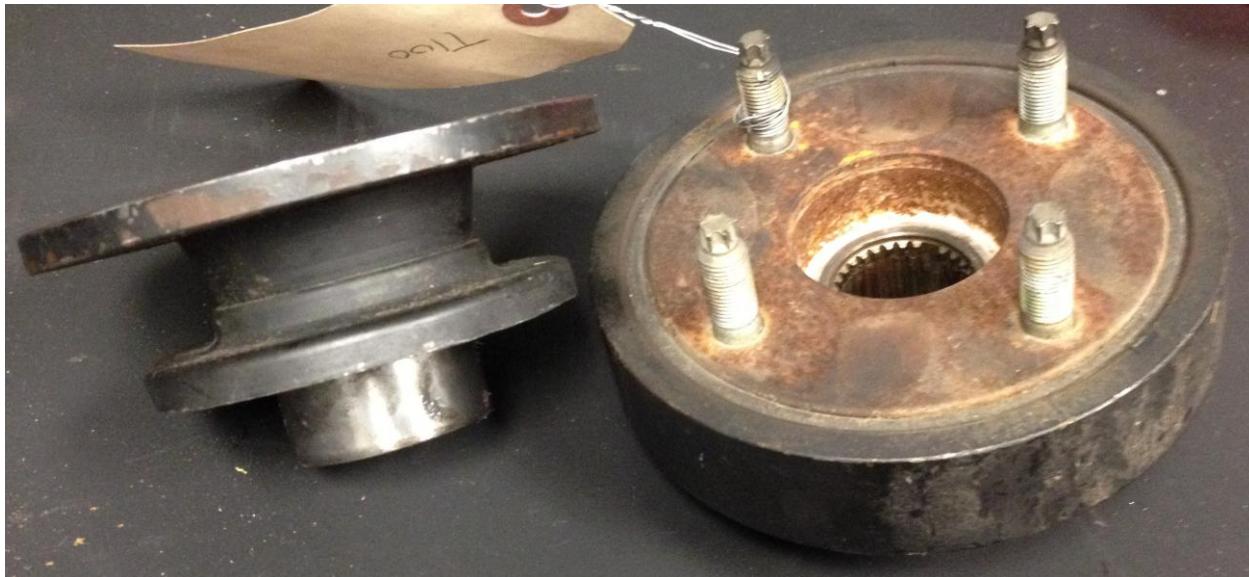
On the left is a traditional Toyota flange. In an effort to control driveshaft harmonic imbalances Toyota installed these harmonic yokes pictured on right (Thick Rubber infused flanges with Studs versus the Standard thin style with bolt and Nut configuration)
